**TECHNICAL AND INVESTIGATIVE SUPPORT FOR HIGH
DENSITY DIGITAL SATELLITE RECORDING SYSTEMS**

Progress Reports #12 - 15

NASA Contract No. NAS5-26493

TECHNICAL AND INVESTIGATIVE SUPPORT FOR
HIGH DENSITY DIGITAL SATELLITE RECORDING SYSTEMS:
MAGNETIC TAPE SURFACE DEFECT ANALYSIS

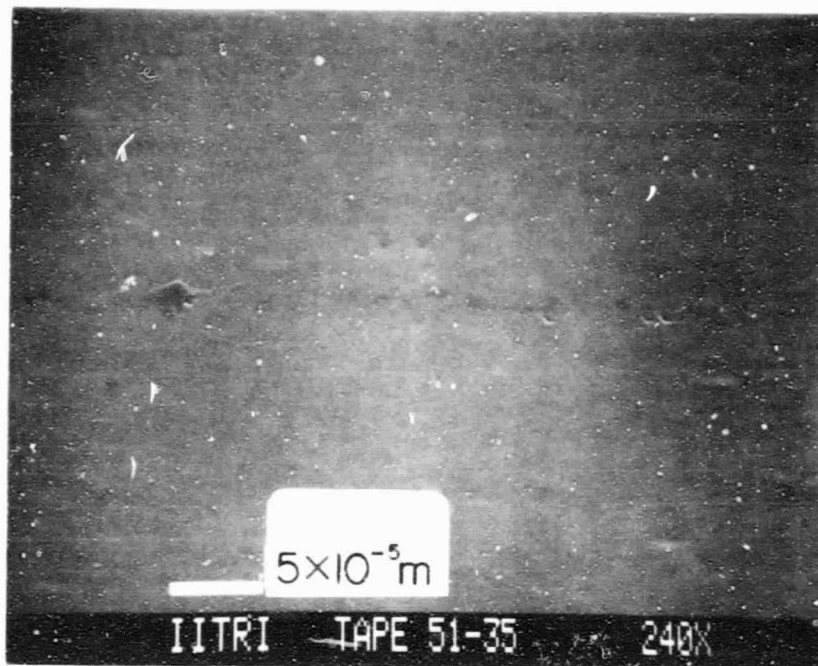
Figure 5.15 - SEM with Defect 3M 5198-35-D at left center and three members of a typical gouge array at right center. Pits above track are electron beam damage that occurred during EDAX of Fig. 5.3b.

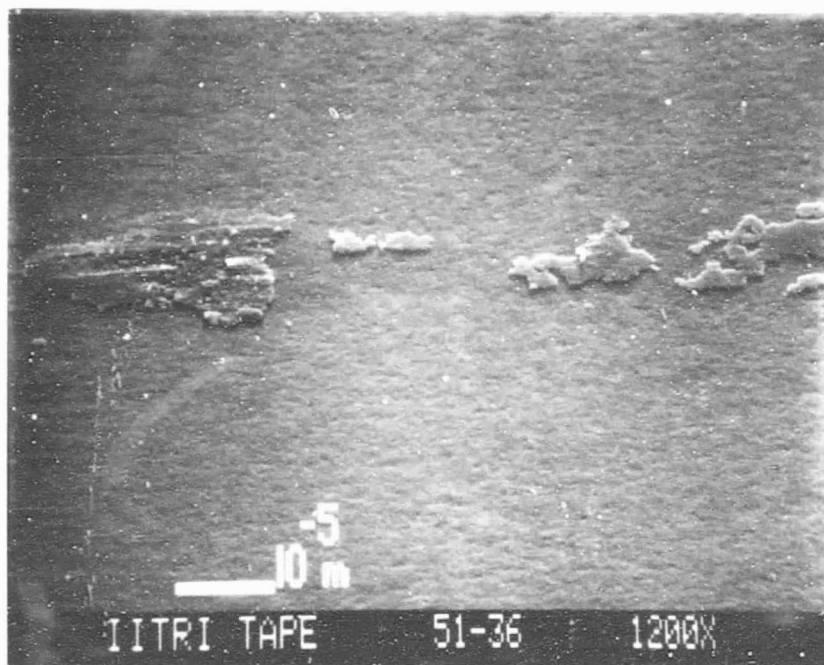
The SEM of this defect in Figure 5.16 shows a particle with a worn surface which distinguishes it from the smooth surfaced defect -35-D.

Figure 5.16 - SEM of Defect 3M 5198-36-D

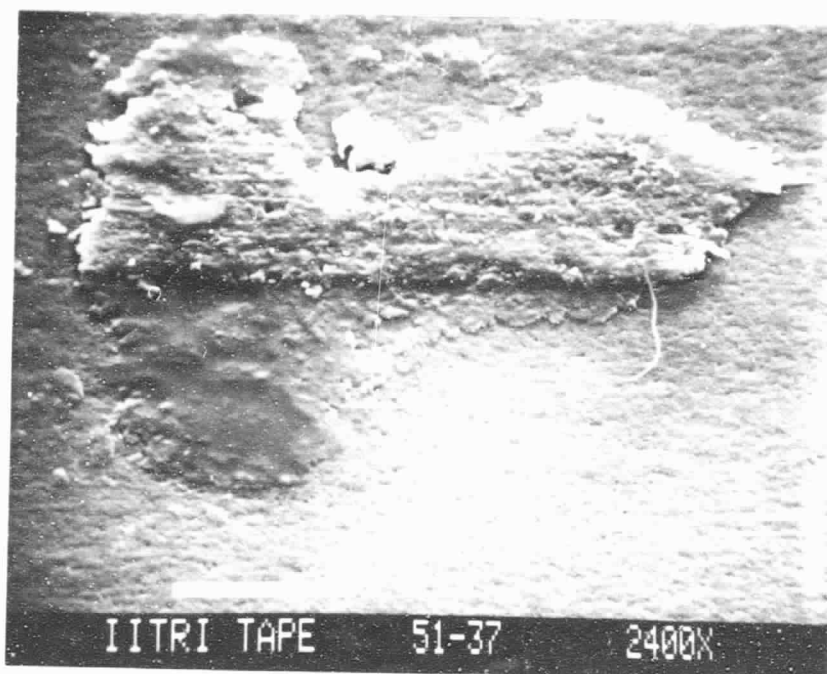
Figure 5.17 - SEM of Defect 3M 5198-37-D

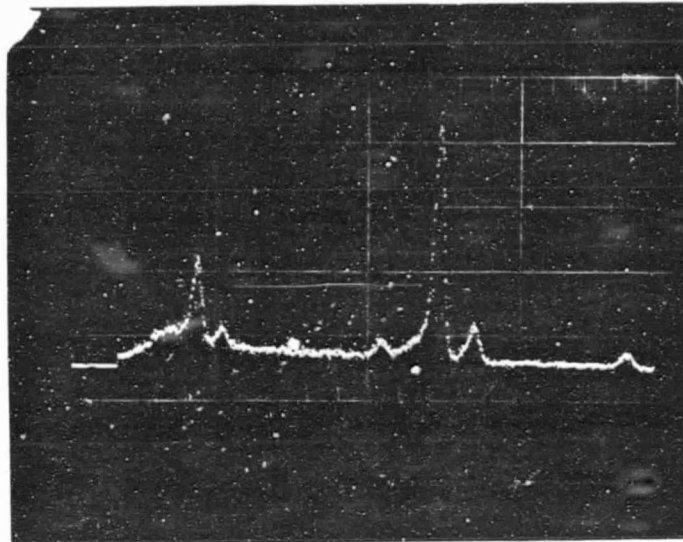
Figure 5.18: EDAX of Normal Fuji H621
Oxide Binder

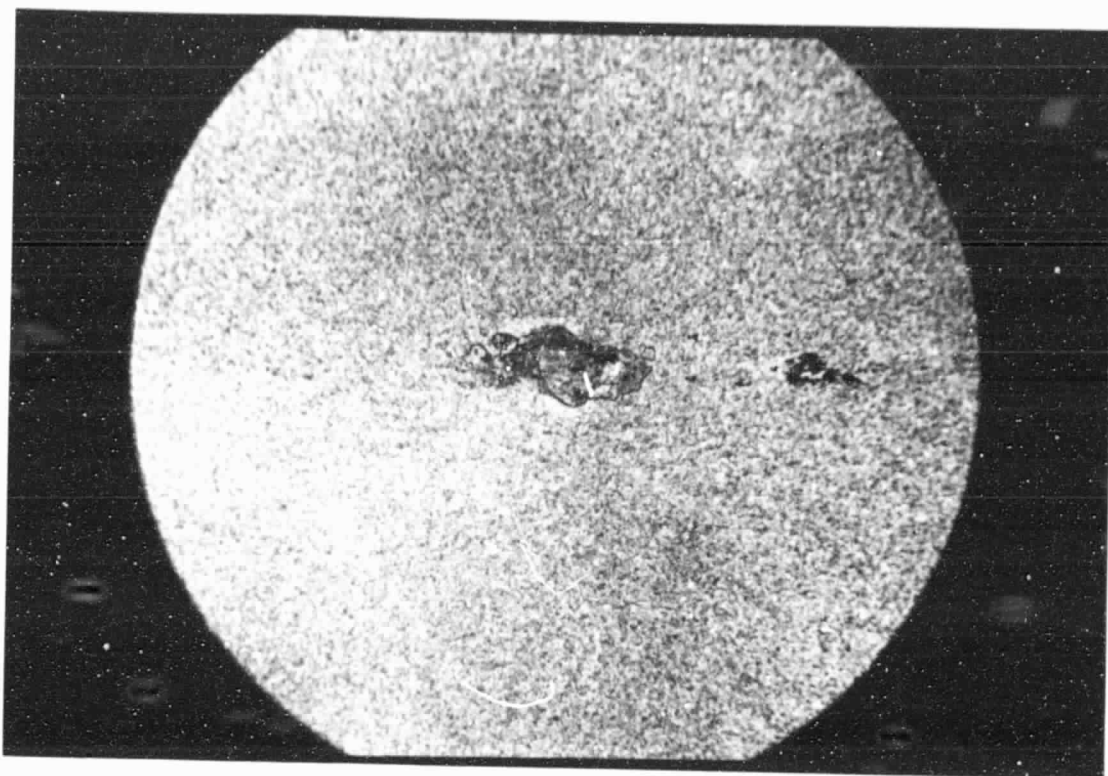
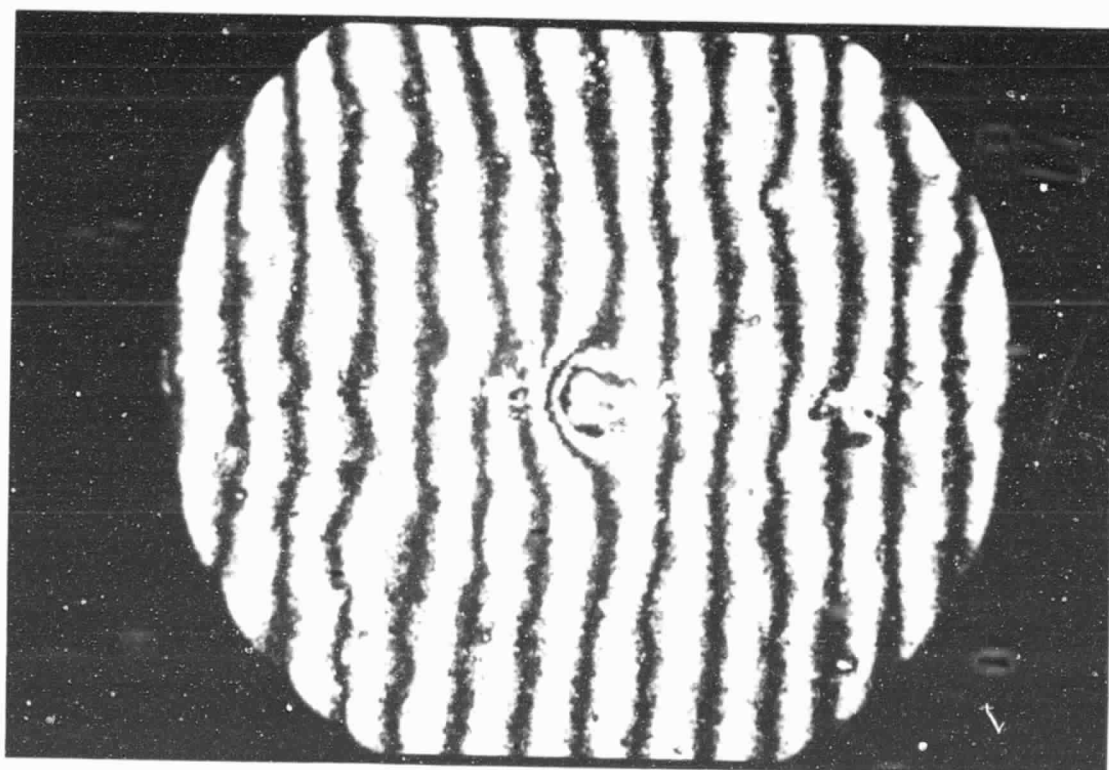
Figure 5.19b is the interference photomicrograph of this defect indicating a departure from the smooth normal oxide surface that starts at the outer edge of the light ring. Deflection of the bands in the same direction as swales indicates a depression surrounding a center with a sharp profile transition of indeterminate direction. A depression is also indicated near the smaller optical feature.

Figure 5.19 - a) Bright field micrograph and b) Interference micrograph of defect Fuji H621-01 (360X magnification).

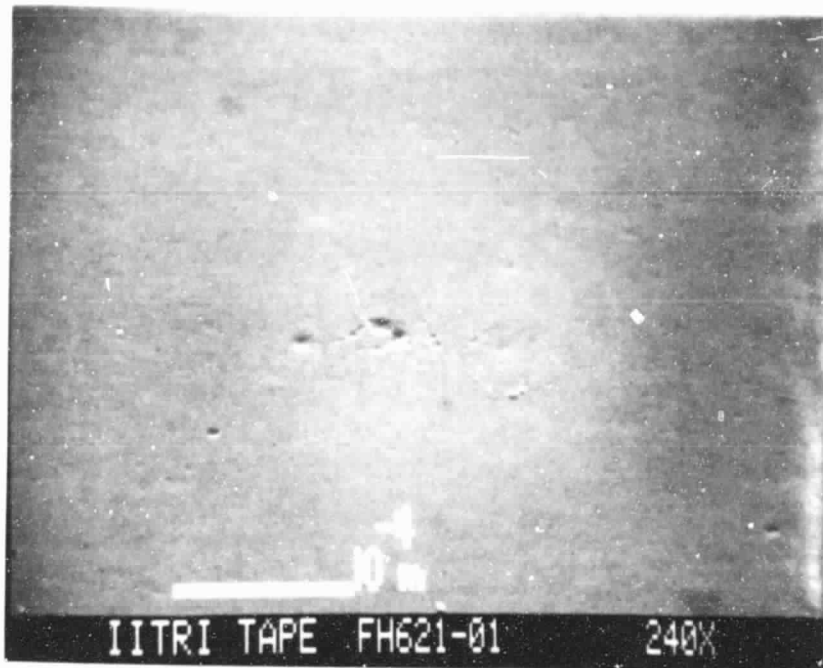
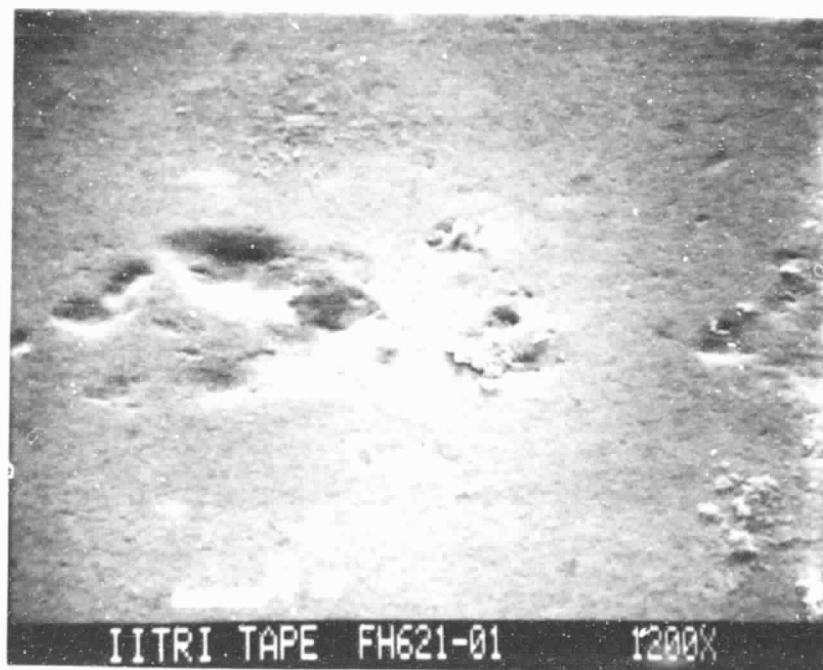
Figure 5.20 - SEM's of Defect FH621-01

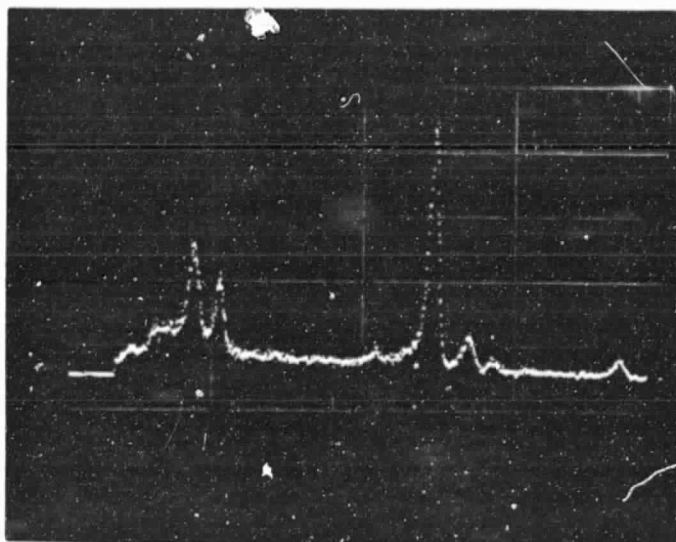
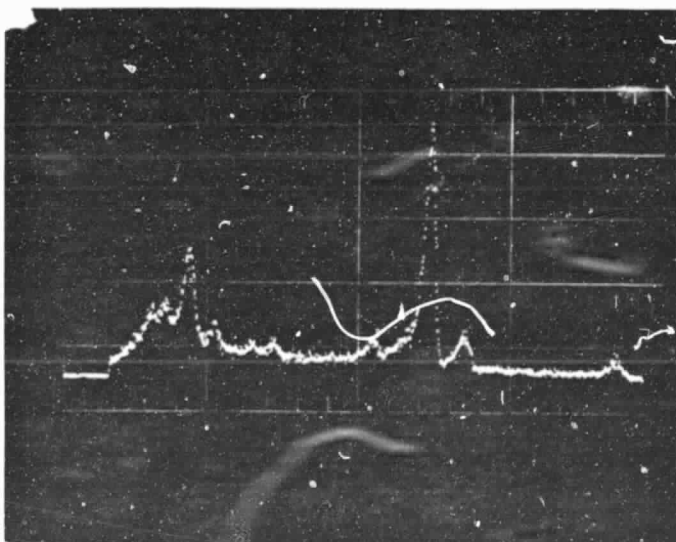
Figure 5.21: EDAX of a) large inclusion and
b) small inclusion of defect
Fuji H621-01.

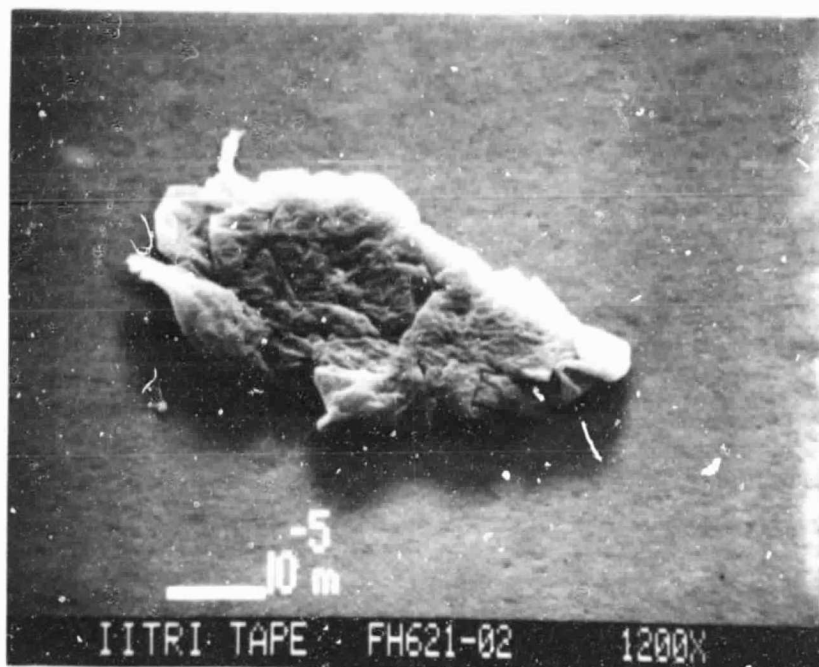
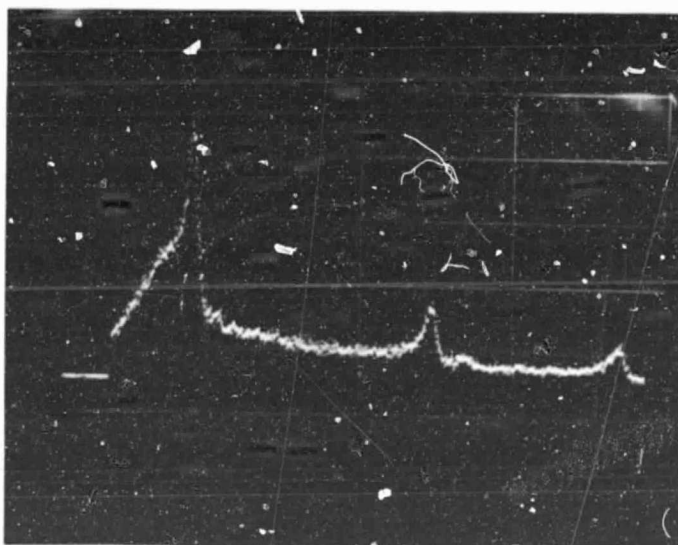
The dropout associated with this defect was noted once while imaging a nearby dropout during the virgin recording. The dropout counts at the same location after the second recording led to the localization and identification of a highly reflective 2 mil long feature that was centered just off the track positions employed in its detection and the other imaging procedure. The surface of the feature was too rough for profile microscopy.

Figure 5.22a is an SEM indicating a particle resting on the oxide surface. However, the defect was adherent enough to resist an air jet dusting during sample preparation, and review of its detection suggests that it never passed over the projecting reproduce head. A projecting profile between 50 and 100 microinches is suggested. The EDAX of Figure 5.22b is mostly gold and aluminum artifact with minor iron and chlorine peaks from the underlying oxide, which is indicative of a purely organic material.

Figure 5.22 - a) SEM and b) EDAX of
Defect Fuji H621-02

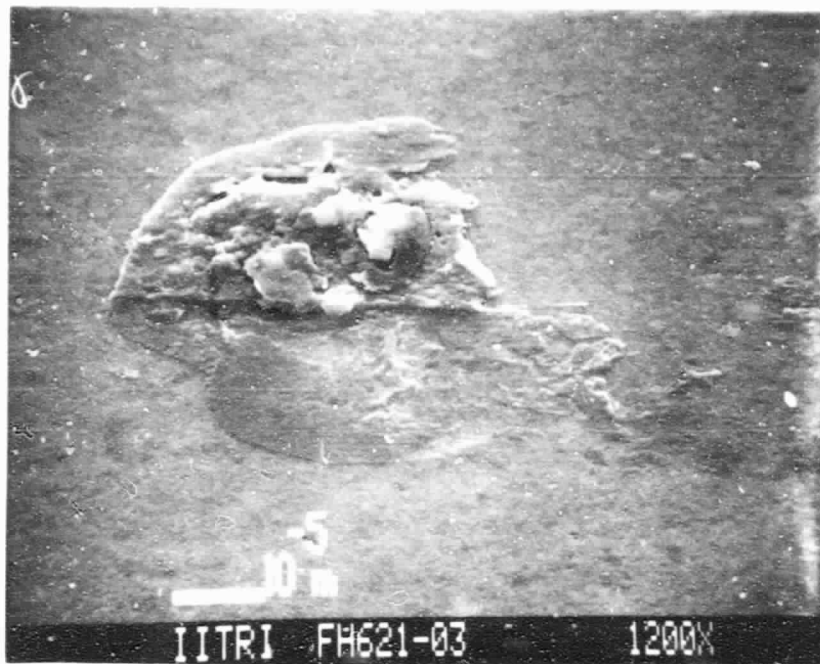
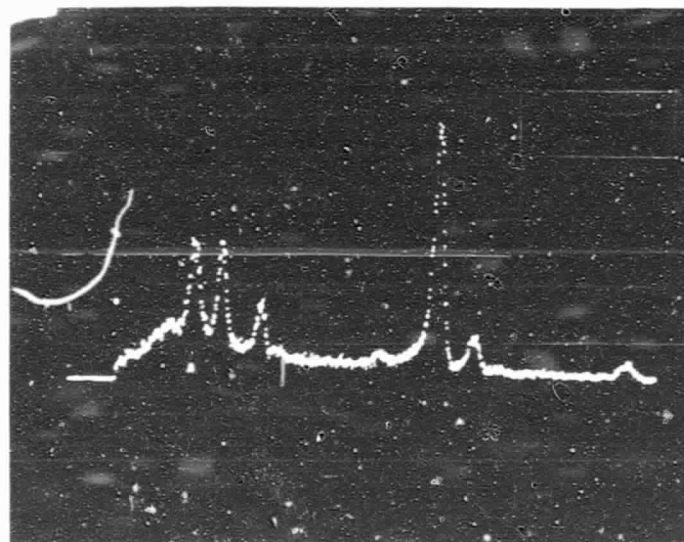
Figure 5.23 - a) SEM and b) EDAX of
Defect Fuji H621-03
